Justin & Mallory Fiske (Owners) 1517 Iroquois St Indian Village HDC Project Review Request Wall Replacement with Living Fence

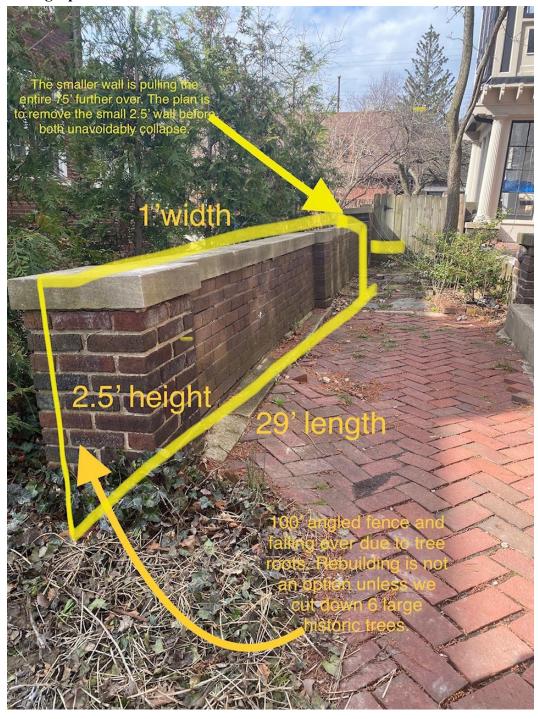
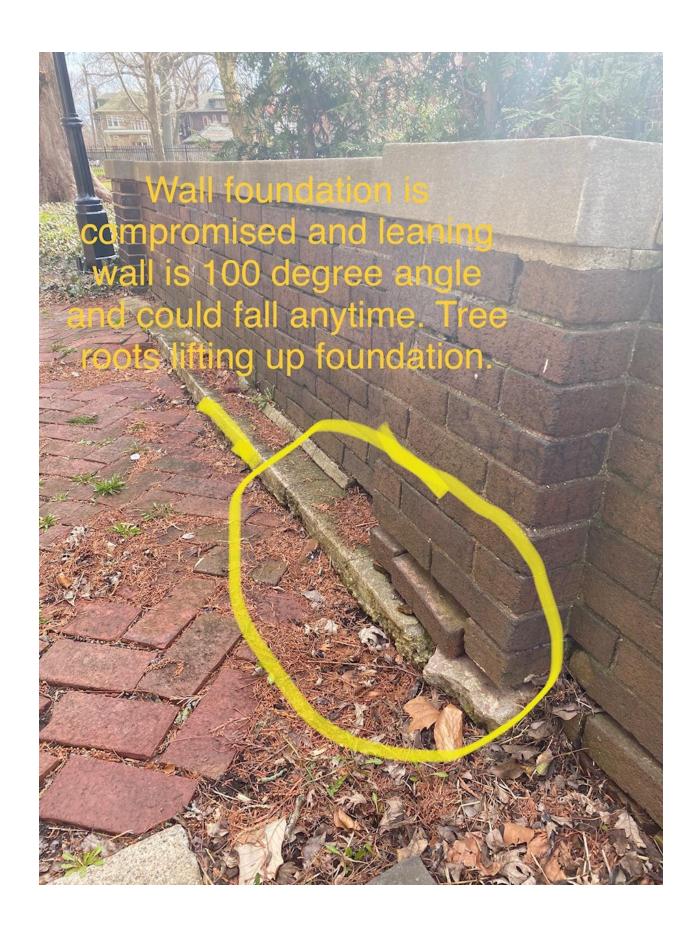
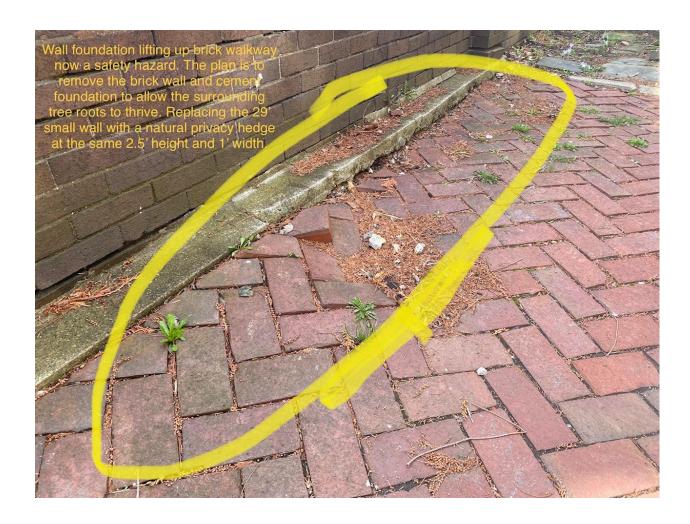
Due to historic tree roots planted after house was built, the smaller, 29' length, 2.5' high privacy wall foundation is compromised. The small brick wall is now at a 100 degree angle; foundation lifting above surface and lifting up brick walkway. Safety concerns with small children playing near fence and the adjacent walkway. Tree roots will continue to compromise small wall. The small wall is attached to a larger 3' and subsequent 5' wall. Because the smaller wall is further leaning, it's taking down the rest of the wall with it. We are unable to replace the small brick wall unless we remove the historic 100' tree and privacy trees on the 1507 Iroquois St side of the wall.

- Replace the small 2.5' high wall with a living fence hedge "Yew" based on historic guidelines.
- Repair 3' larger brick column where the small and large wall meet to preserve it from further leaning and falling over.

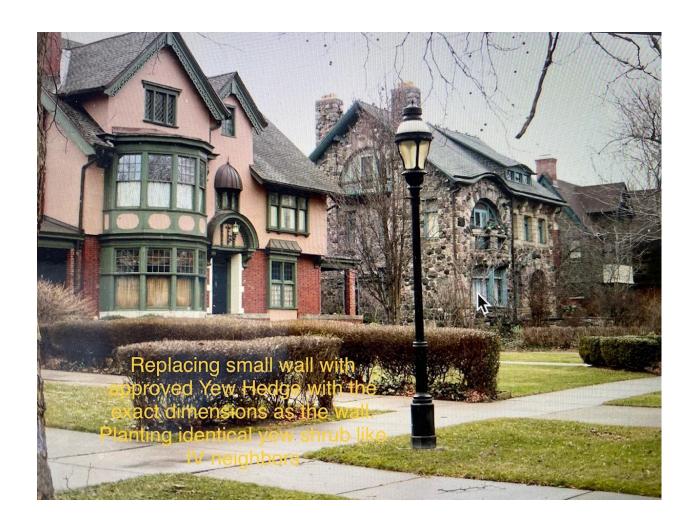
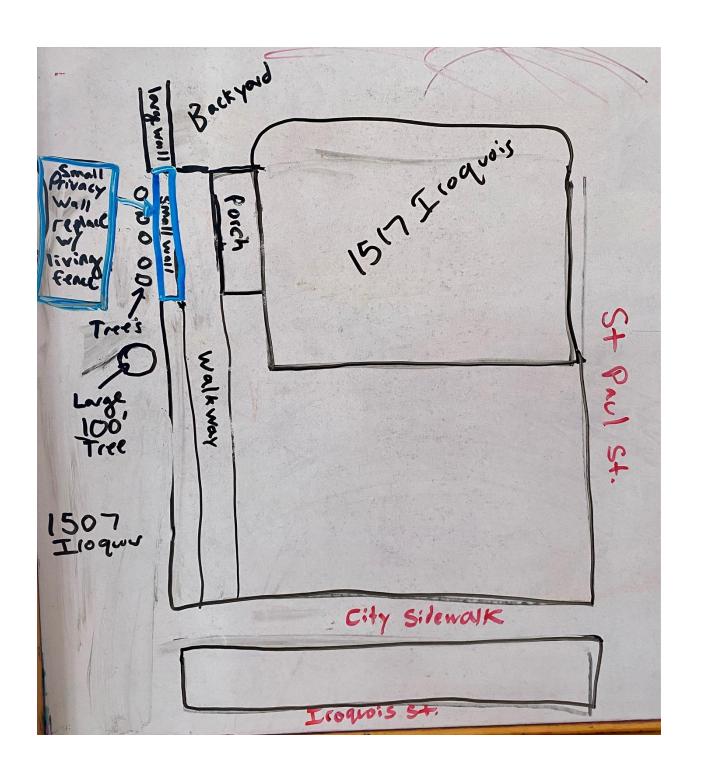
Note: The small 2.5' wall is attached to the larger wall that runs between 1517 Iroquois and 1507 Iroquois St property line. The small wall is angled at 100-110 degree angle and is bringing the larger wall down with it. If no action is done, the whole wall will come down. This plan is to avoid further damage to the larger brick wall and also preserve it. The Small wall is beyond repair with the foundation compromised.

Replace the small 2.5 foot wall with a historic living fence hedge per guidelines. We'd have to cut down the historic trees or replace the small brick wall with a living fence; otherwise a replacement small wall will inevitably suffer the same consequences with the tree roots lifting up the wall again. After the small wall and foundation is removed, the plan is to repair the 3' wall column which will become the end column, and then proceed to install the exact dimensional (29' length, 2.5' high, 1' width) living fence hedge according to HDC guidelines.
